A New Type of Periprosthetic Fracture: Is It the Time to Update the Unified Classification System?

Rajesh Malhotra¹ · Deepak Gautam¹ · Saurabh Gupta¹

Received: 11 June 2021 / Accepted: 27 September 2021 / Published online: 3 October 2021 © Indian Orthopaedics Association 2021

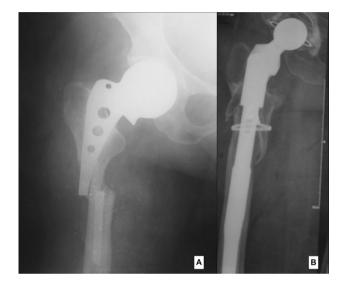
Fig. 1 A and B Radiograph showing periprosthetic femoral fracture with fracture of Austin Moore Prosthesis (A). Revision surgery was performed with a modular stem (B)

Case 1. A 66-year-old lady presented with periprosthetic femoral fracture with mid-stem fracture of insitu Austin Moore Prosthesis done 11 years back for fracture neck of femur (Fig. 1A). The proximal prosthetic fragment was removed by disrupting the implant bone interface using a reciprocating saw and reverse hitting the prosthesis subsequently. The distal fragment was removed after disrupting the prosthesis-bone interface by multiple drilling with K-wires and use of trephine reamer. As both the proximal and distal fragments had good bone, revision surgery was done with modular stem prosthesis and cemented cup (Fig. 1B).

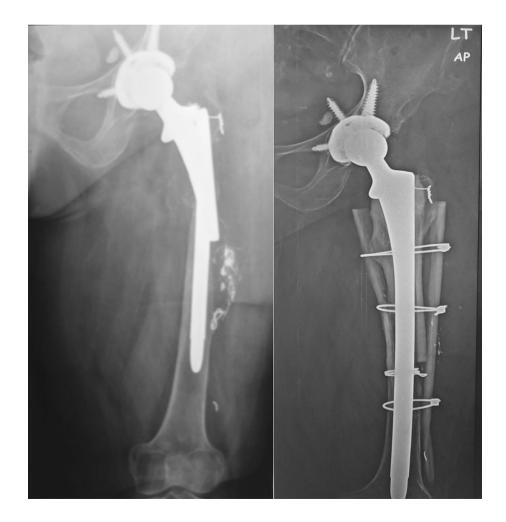
Fig. 3 A and B Radiograph showing periprosthetic femoral fracture with fracture of a cementless fully porous coated cylindrical stem (A). Revision surgery was performed with a allograft prosthesis composite and supplemented with circumferential struts (B)

Case 3. A 55-year-old female underwent primary total hip arthroplasty with a long cylindrical stem for failed osteosynthesis of proximal femoral fracture. She presented with femoral shaft with mid-stem fracture following trauma (Fig. 3A). There was massive bone loss from the proximal femur, which eased the removal of proximal fragment. The distal fragment of the broken prosthesis was removed with trephine reamer. Considering the age of the patient, revision surgery was performed using proximal femoral allograft prosthesis composite (Fig. 3B). As she was osteoporotic, the construct was augmented with struts around the APC-host bone junction. The acetabular component was well fixed without any poly wear and hence was retained.

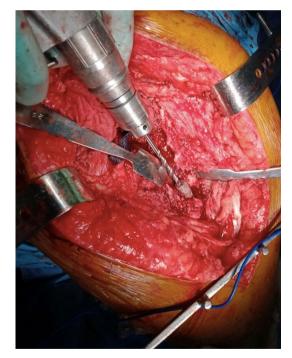
Fig. 5 Intraoperative picture showing drilling of the exposed upper surface of the distal fragment
